TALGO, INCORPORATED

NTSB Accident Number: RRD-18MR001

Proposed findings in relation to the behavior of the railroad rolling stock involved and recommendations for improved safety in connection with the derailment of Amtrak Train 501, DuPont, Washington, Dec. 18, 2017

FINAL SUBMISSION

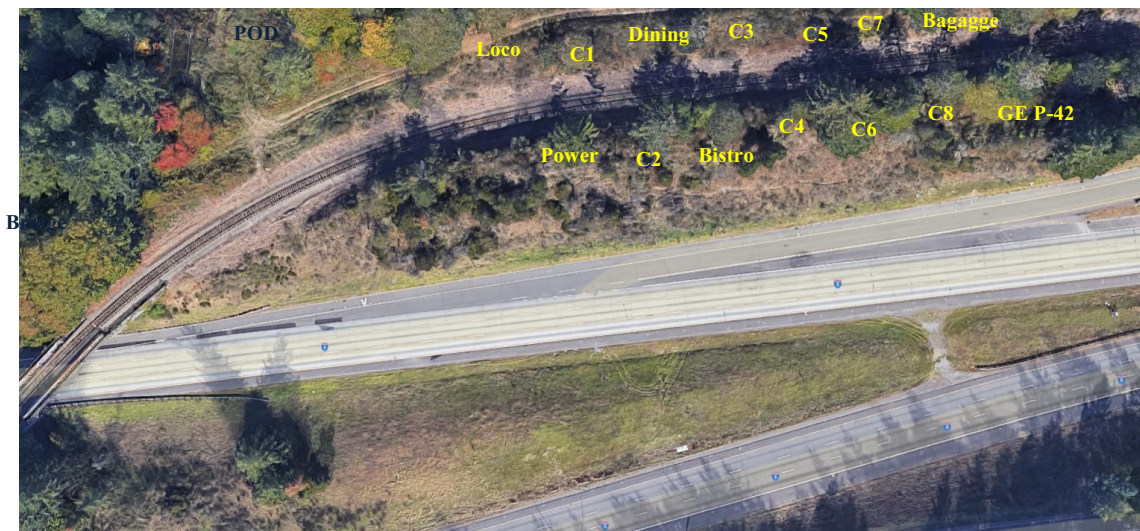
Figure 5 Point of Derailment

According to the NTSB Preliminary Report⁴ the train, led by the Siemens locomotive, reached the point of derailment, on the entrance spiral of curve 19A-1 at approximately mile post 19.9 at a speed of 78 mph. The speed board⁵ (shown in Figure 4) limits the speed here to 30 mph.

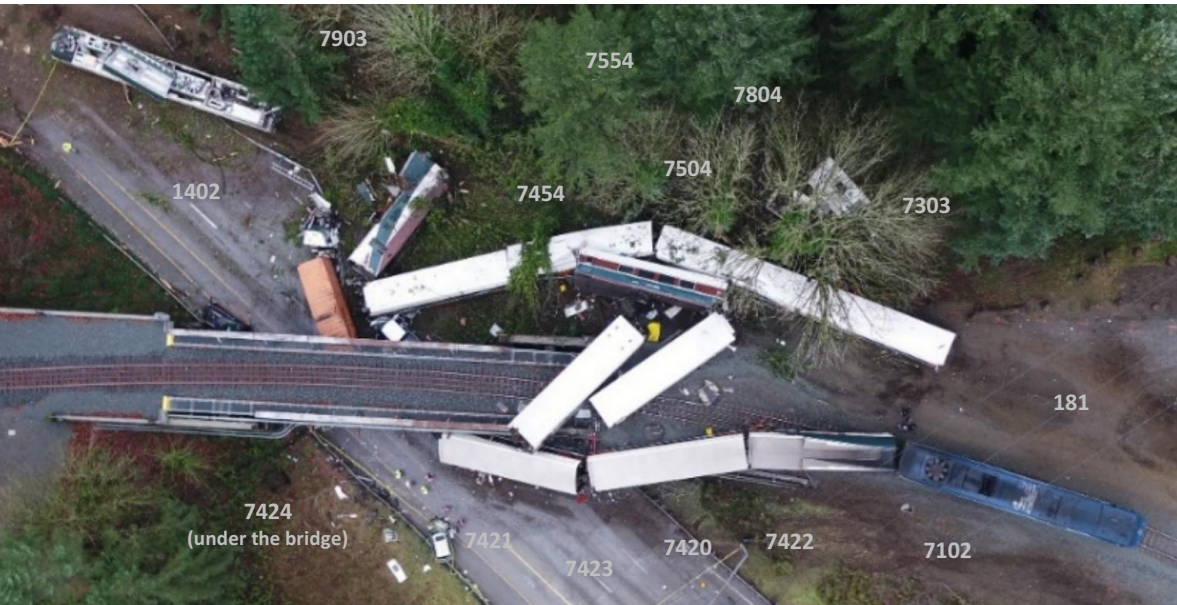
Figure 12 Final location of the equipment after the accident

C7 7421, which lead this group, passed the point of derailment without derailing and remained on the track until forces from C6 7420, which had rotated, caused it to derail to the left of the track, falling down the subgrade onto C4 7424, by now lying overturned on I-5. At this point a truck hauling an ISO container on a chassis and traveling south on the highway impacted the C4 7424 (and scratched C7 7421). The truck pushed C4 7424 under the bridge and moved C7 7421 in the same direction, coming to rest beyond the bridge. The rolling assembly on C5 7423 remained attached, with one of its wheels hitting the right side of C7 7421, now below it. The C7 7421 truck (RRG-0032) separated from the car, falling on the right side of I-5. C8 7420 then derailed, being pulled by C7 7421. Only one end of baggage car 7102 (and all four axles of the rear locomotive 181) remained on the track.

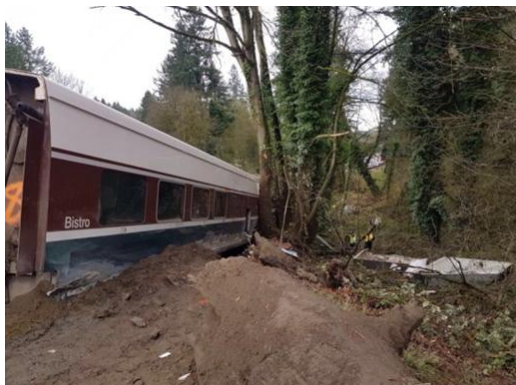
Bistro 7303 has followed the locomotive into the woods

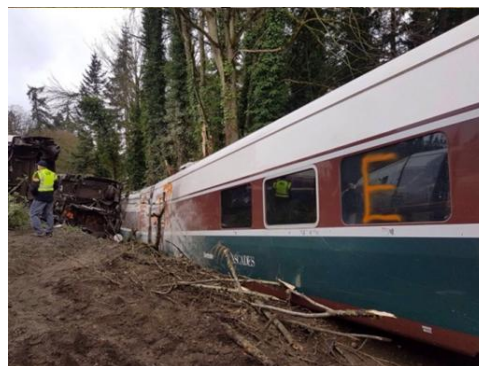
Bistro 7303 Left side

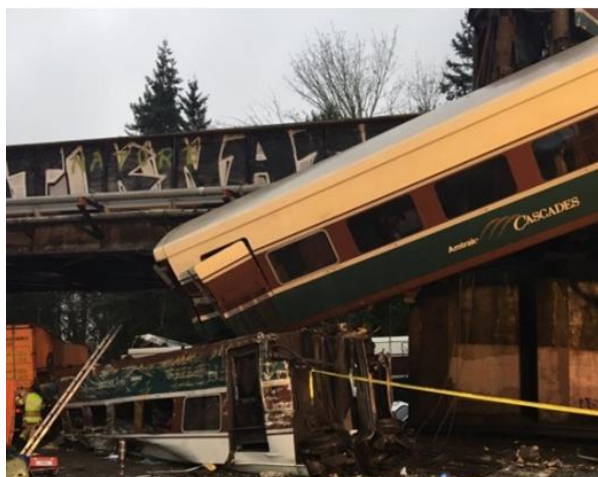
C7 7421 rests on C4 7424 (upside down under the bridge)

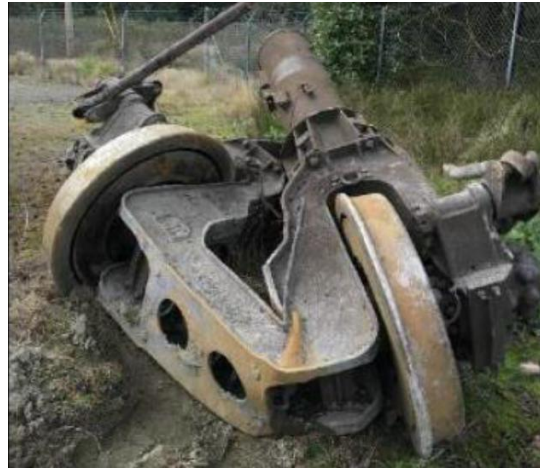
Figure 37 Deformed rolling assembly, made of 1/2 in. steel plate

It is, however, not clear how much securement would have been required to retain the rolling assemblies under the unknown accelerations and forces experienced at DuPont. Figure 37 provides an idea of the forces involved in the accident.

To increase the safety level of the rolling assembly attachment, Talgo proposes the addition of new straps to increase the retention capability beyond the FRA requirement. This modification is discussed in Section 5.

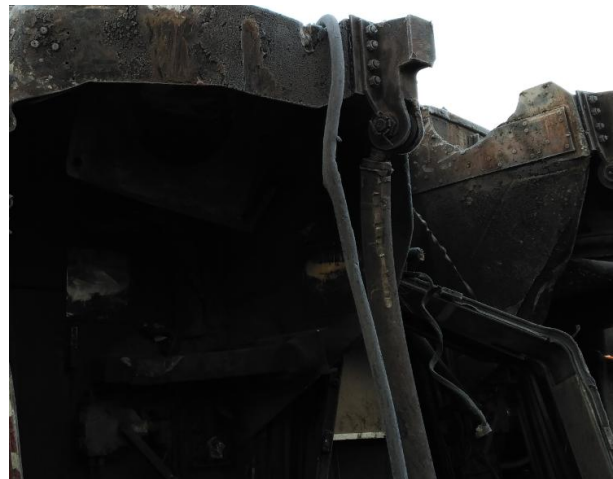
Figure 40 bistro 7303\ weight bearer bar buckling

Under the loads indicated in CFR the most critical condition is the buckling failure of the bars. This condition was apparent in several cars such as diner 7804, bistro 7303 and C5 7423. This effect is shown in Figure 39 to 41, where no failures of attachments are detected but severe deformations of suspension tower supports did occur. These deformations show that the forces produced during the accident greatly exceed the 100,000 pounds required by the current regulation.

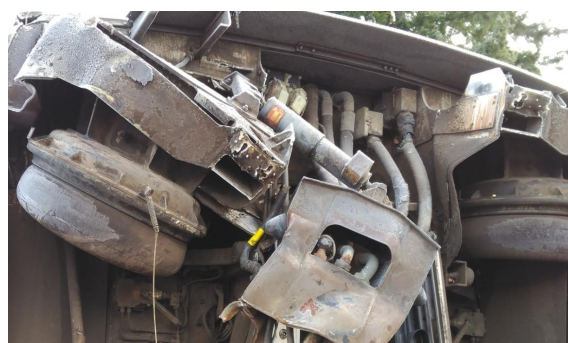
Figure 44 C7 7421 tear off detail

In some cars the aluminum plate where the weight bearer bars were attached had been torn off from the tower support. This failure was caused by very high forces as can be inferred from Figure 43 and 44, where the car body structure was severely deformed by these vertical loads.

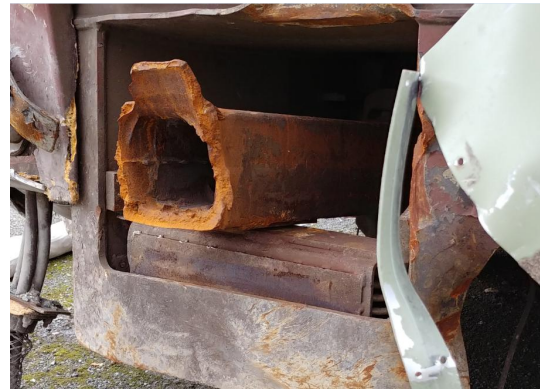
Figure 46 Power car 7903. AAR coupler (2)

The couplers on Talgo end cars are Type H Tightlock couplers in accordance with AAR (now APTA) standards (Talgo Technical Specification ET-0213). This coupler on power car 7903 was broken due to the forces produced when the buff forces (produced by the decelerating locomotive) caused lateral forces that rotated power car 7903. Post-accident inspections reveal deformations consistent with torsional and bending loads in the power car and the locomotive. Figures 45 and 46 show torsional and bending deformations on the power car coupler. Figure 47 and 48 show the torsion effects on locomotive coupler.

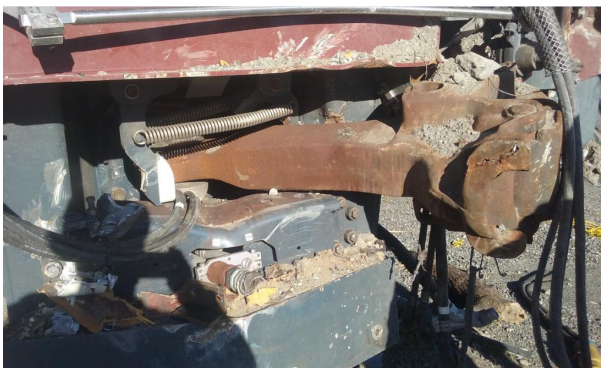
Figure 47 Loco 1402. AAR coupler (1)

The unstable pinned connection between the locomotive’s coupler and its draft gear yoke is evident in Figure 47. The result was that under heavy buff loading the coupler moved far to the right, displacing the front end of power car 7903 in that direction and allowing C1 7454 to push the rear end of that car to the left, rotating it 90 degrees clockwise (as seen from above) and into its final position.

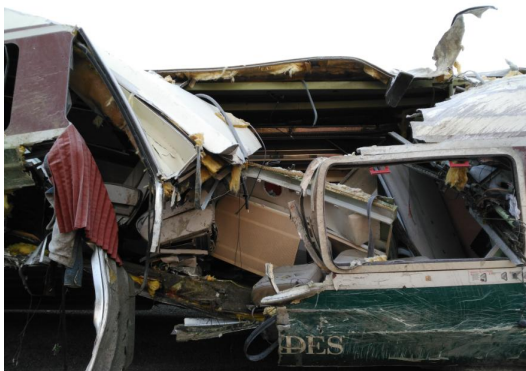
Figure 54 C3 7504. Side impact evidence (2)

According to the accident sequence described in 1.2, C3 7504 received a high speed side impact against the overpass approach fill retaining wall, causing extensive damage at that point (and possible immediately following this collision). As can be seen in Figures 53 through 56 below, this extensive damage could not have been produced by the truck that detached from C6 7422, three cars to the rear, but it could have easily been produced by impact with the concrete wall. One block from this wall, which was partially demolished by the impact for the train, is visible immediately to the left of the detached truck in Figure 56. All three deceased passengers were in this car.

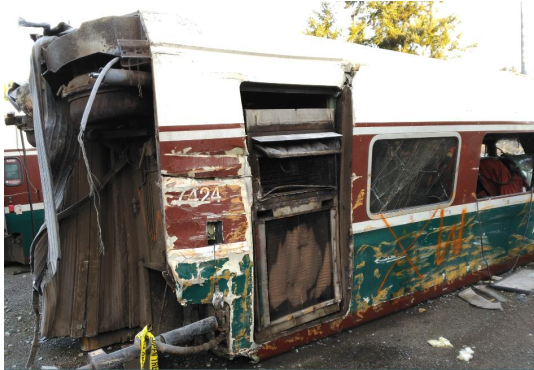
Figure 57 C4 7424. Side impact evidence (1)

During the accident sequence, C4 7424 was subjected to much more severe side and roof impacts than those required by the CFR. The car fell onto its roof under dynamic, not the “quasi static” conditions of 49 CFR 238.215, and then, while it was resting on its roof and supporting some additional weight from C7 7421, substantially increasing the vertical load, it was struck on the left side by the combination tractor semitrailer that was southbound on I-5, the condition anticipated by 238.217 for an otherwise

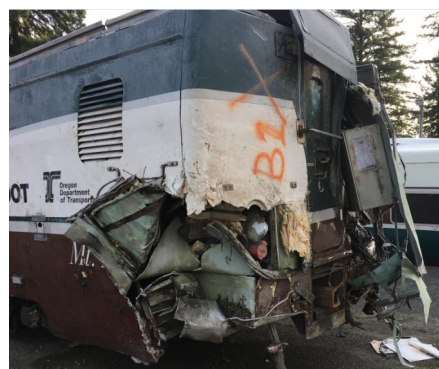
Figure 62 7103 Power car. End detail (2)

While severe damage to the end fairing of power car 7103 was apparent during the inspection at JBLM, the steel structure that forms the collision posts was found to be undamaged. (See Figures 61 and 62)

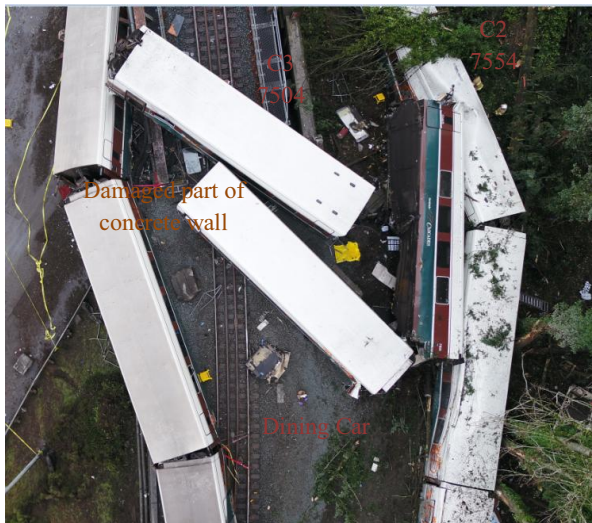
Figure 80 C3 7504. Final position

- After the impact against the concrete wall, C3 7504 came to rest on top of C2 7554 and dining car 7804. The truck that belonged to C6 7422, three cars to the rear, was found under and next to C3. Part of the concrete wall was also found there. (Figures 80 and 81)

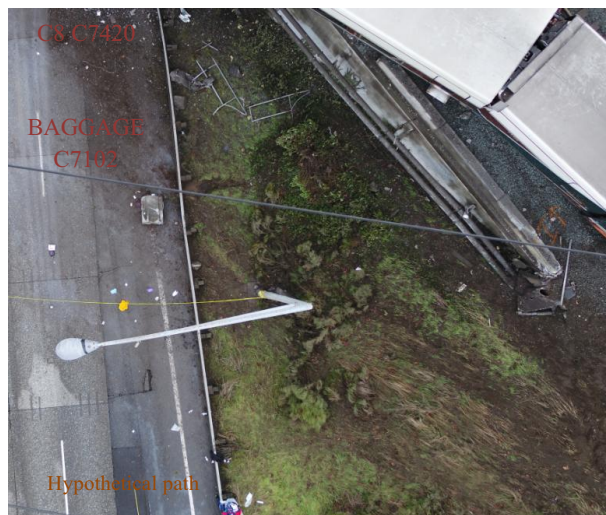
Figure 91 C4 7424. Hypothetical path of derailment (1)

If the C4 had slid along the embankment, there would have been damage to the surrounding infrastructure, but no damage was evident on the guard rail or street light (yellow circles in Figure 91). Thus the marks on the embankment visible in the pictures below were likely there before the accident, requiring rejection of this hypothesis.

Based on the above Talgo believes the probable path of derailment of C4 was a fall from the overpass approach fill instead of a slide along the embankment. Car inspection showed that the right tower support (Figure 94) was extensively deformed, damage consistent with a vertical impact with the highway.

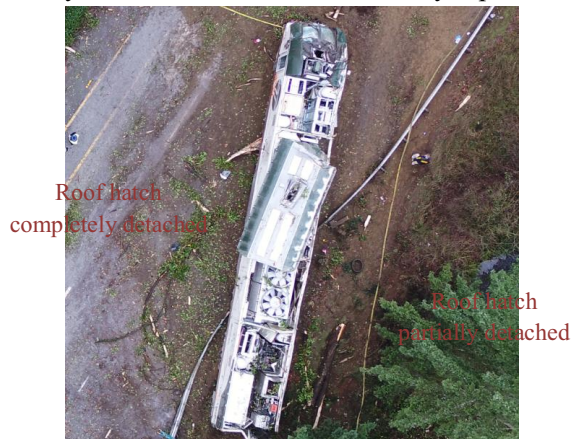
Figure 95 Overall view. Locomotive

According to accident sequence the locomotive did not suffer a heavy lateral impact, but some components such as roof hatches were detached from it. These components, as others involved in the collision, are potentially dangerous to the train crew, nearby drivers or even passengers on the train, all of whom could be hit by these hatches. They have not been addresses in any report we have seen to date.

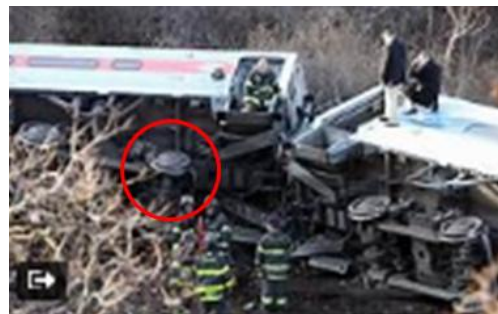
Figure 99 Detached truck, Bronx

At the time of this accident the train was running at 82 mph in a 30 mph restriction. The situation was very similar to that at DuPont, but the speed ratio (82/30) was slightly (5%) higher (78/30). The cause of the over speed was inattention by the engineer. In this case the train broke into five parts. (The four failed connections are indicated by the red circles in Figure 98. At least one truck was detached, as can be seen in Figure 99 below.

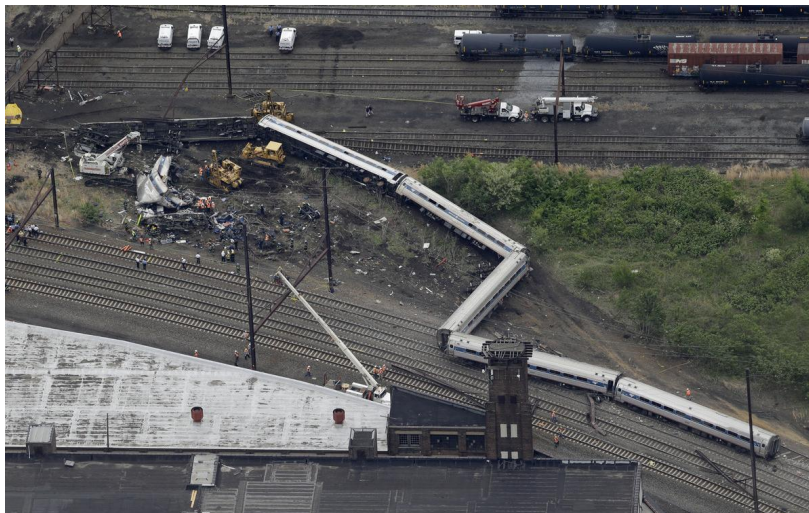
Figure 100 Overall view (1) Frankford

In this case at least four connections between cars were broken, two cars turned over and one car was completely destroyed as can be seen in Figure 100 and 101. In the accident reports mechanical performance and technology are not cited as factors in the accident even though at least four trucks detached and the couplers failed at four or more locations (yellow circles in Figure 100) allowing the cars to overturn. As shown in that figure one of the overturned cars fell onto a main track a considerable distance from the one on which the derailment occurred, the very fear voiced by the FRA findings in the Talgo grandfathering report. That no secondary collision resulted was due only to the absence of additional track structures and other trains. At least five detached trucks are clearly visible in Figure 100 (red circles).

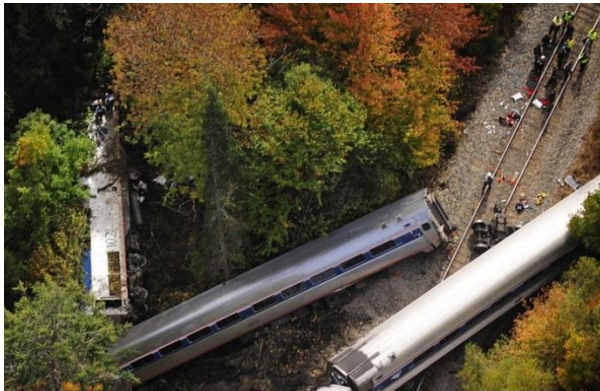
Figure 102 Overall view (1) Northfield

At the time of this accident the train was running at its MAS of 59 mph. The derailment was caused by a large rock slide. The locomotive and four coaches derailed. The locomotive and the first car slid down a steep embankment. In this incident at least two couplers were broken, causing a large lateral displacement of the decoupled cars. Those cars did not foul an adjacent track only because there was none. As can be seen in Figure 102, at least one truck detached. The failed connections between cars are also clearly visible.

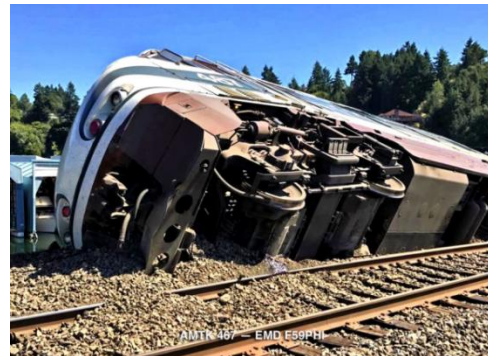
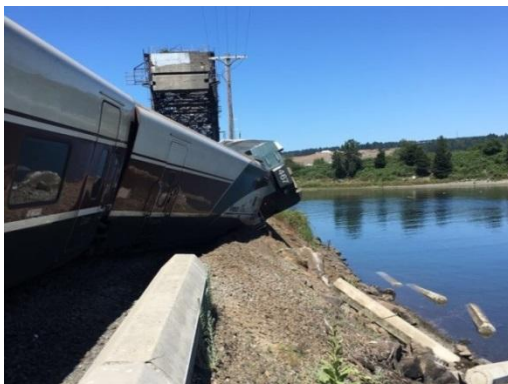
The locomotive turned onto its right side and may have gone into the water but the Talgo train configuration resulted in the entire trainset working together to keep it from rolling more than it did.

This incident conclusively demonstrates the overturning resistance of Talgo equipment that was explained in 2.2.6

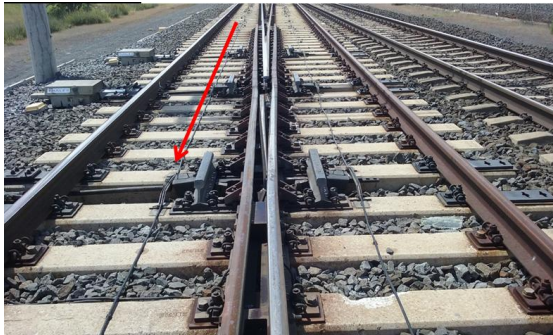
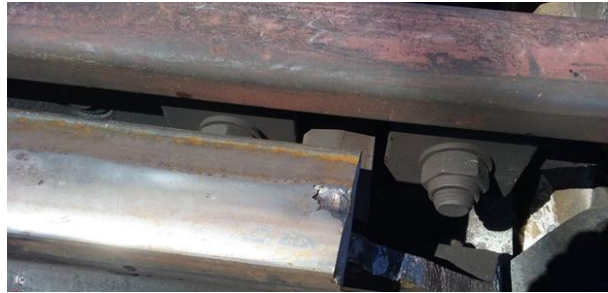
This incident involved a very high speed (Series S112) train set. One wheel of this train impacted a broken rail in a swing nose frog causing the derailment of that axle at 167 mph. The train stopped 1.614 miles [2598 m] from the point of derailment, with the entire trainset on the track except for the one derailed truck. The final investigation showed that the cause of the incident was the broken rail. No injuries and only minor material damage resulted; no plastic deformation on truck frames or tower supports were found.

The behavior in this incident supports the position that Talgo rolling stock presents a high resistance to rollover events as the preceding and following cars prevent the derailment of axles.

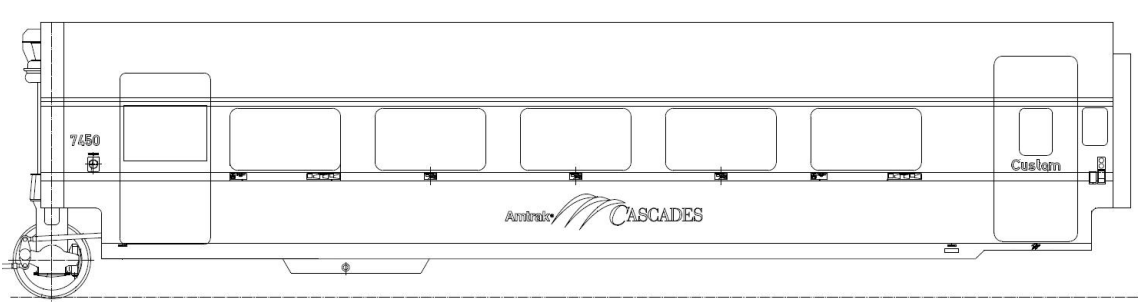
Figure 112 Current location of instruction signage

The emergency windows of several cars were used for egress after the derailment, but several passengers and first responders reported that the instructions were confusing. On the exterior, under each side window there is a sign which indicates the proper way to use the window in case of emergency. Currently the non-emergency windows are marked at the bottom with the text “*EMERGENCY Talgo Window removal. All windows are breakable using a sharp, heavy object*”. Emergency windows have two different pictograms at the bottom: “*Emergency exit*” and “*Emergency instructions*”. Talgo propose to change the pictograms as follows:

1. The pictograms should be placed at the quarter points as shown in 3. (Currently the pictograms for emergency windows are located at the ends of the windows as shown in Figure 112.)

2. Each text should refer only to one window. The text should indicate “*EMERGENCY. This window is breakable using a sharp, heavy object*”.
The pictograms for emergency windows should not be changed.
